# PULSED PLASMA PROPULSION TECHNOLOGY

FINAL REPORT FOR PERIOD 10 MARCH 1972 - 30 MAY 1977

FAIRCHILD INDUSTRIES, INC.  
FAIRCHILD REPUBLIC COMPANY  
FARMINGDALE, N.Y. 11735

SEPTEMBER 1977

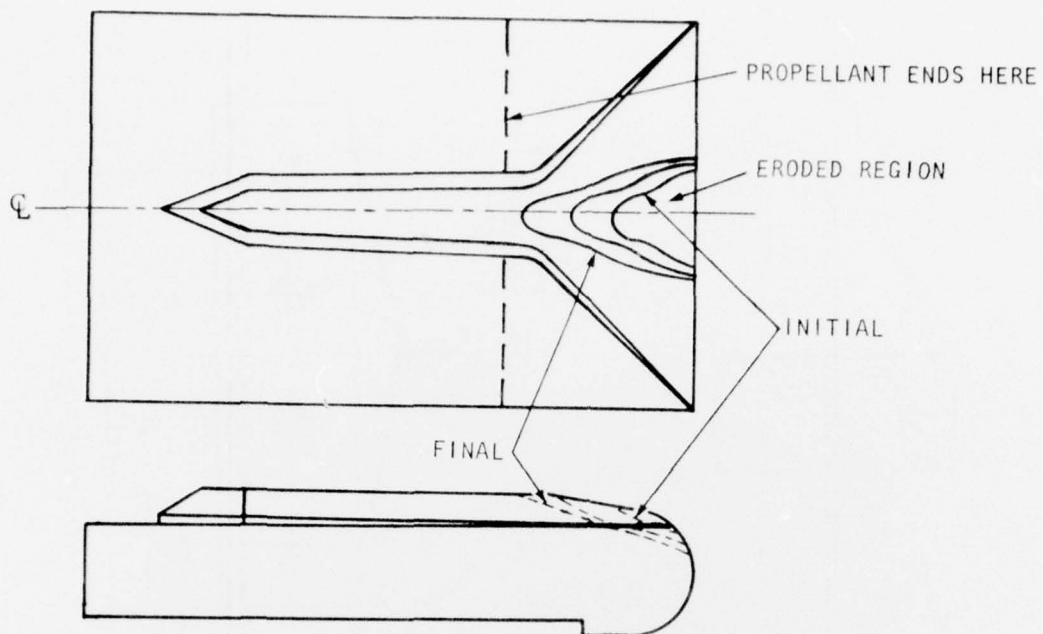
Figure 6. Qualitative Sketch of Progressive Anode Erosion

cathode design was incorporated in attempting to eliminate carbon build-up within the ignitor plug cavity. Erosion of the thruster anode could be considered severe enough to represent a potential failure mode for the system because of the resulting reduction in height of the propellant retaining shoulder in the vicinity of the outermost (i.e., furthest downstream) propellant section. It is interesting to note that the majority of the anode surface exposed to the discharge remains practically erosion free. Erosion begins to become visually apparent at the downstream end of the electrode and the eroded area very slowly propagates upstream as discharges accumulate. An engineering drawing of the anode electrode as initially manufactured for this test is presented in Figure 5. A qualitative picture of the erosion pattern as it has been observed to progress during testing is presented in Figure 6 to illustrate the above statements. The area of severe erosion begins to enter the region between propellant rods after approximately 6 - 700,000 discharges and continues to propagate into this region as time goes on. A photograph of one of the electrodes used during the test is presented in Figure 7 showing the degree of erosion after approximately 820,000 discharges. Anode electrodes were manufactured from copper, tungsten, and Molybdenum during this program to assess the relative erosion resistance of each under actual long-term thruster operating conditions. Quantitative data on the degree of erosion was not generated for each of these materials but visual observations at various times during testing were made. On the basis of these observations it can be said that the general character of the erosion pattern depicted in Figure 6 was the same regardless of which material was used and that thruster propulsive performance remained unchanged with material substitution. Indications were that Molybdenum would last longer than either copper or tungsten. Presently it is questionable whether any of these materials would survive the required life for the system with the original geometric configuration that was tested and as a result a program will be carried out to investigate the problem of erosion as it relates specifically to this thruster system. A certain amount of basic independent research will be performed during that program but the major portion of the work will be an experimental evaluation of several different approaches to elimination of anode erosion of the fuel retaining shoulder as a potential failure mode for this system over its design life. The electrode erosion program is scheduled to commence in the immediate future. The prognosis for developing a solution to this problem is excellent at this time because of several ideas of significant merit.

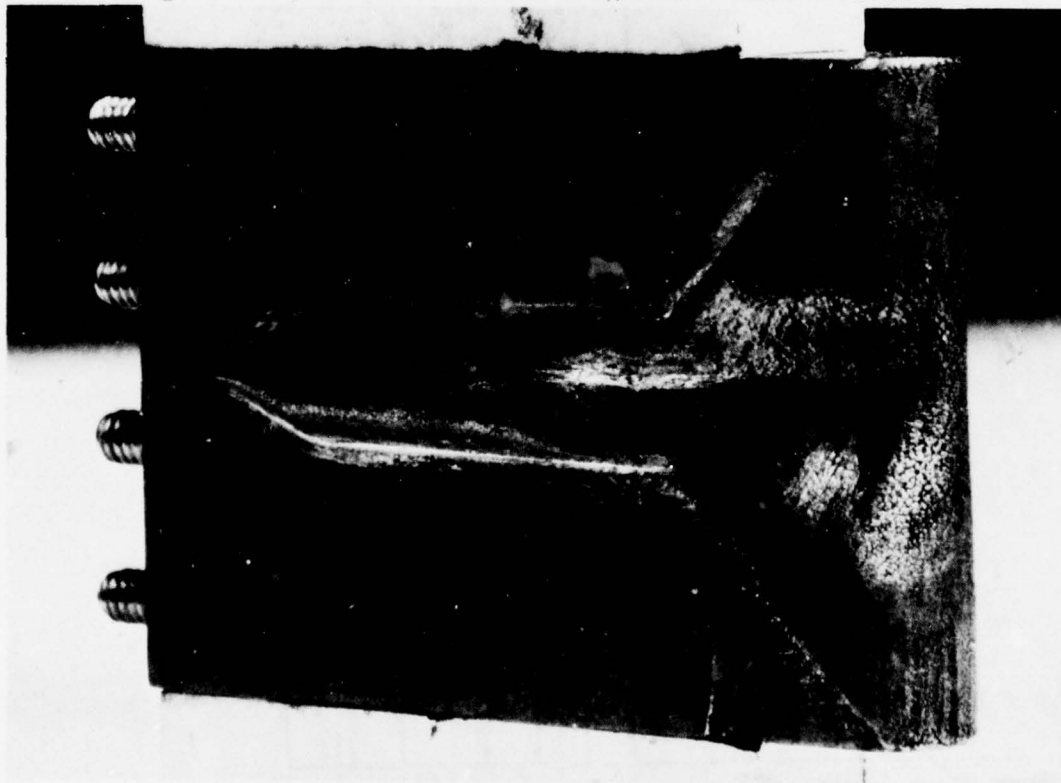
Figure 7. Photograph of Copper Anode After 820,000 Discharges

Two fundamental problems were encountered during the endurance test run on this system. These were anode electrode erosion and carbon deposition on the ignitor plug. Both of these problems, having necessitated mandatory shutdown of the thruster during testing, represent possible system failure modes. Modifications were made to the thruster during the endurance test in attempting to resolve these problems and although testing allowed for some partial evaluation of those modifications, the duration of the testing did not allow for a definite assessment of the modifications.

Based on the tests of the three electrode materials during this program it appears that Molybdenum exhibits least erosion of the anode surface. Hence, the refurbished thruster system is being provided with a copper cathode and Molybdenum anode. The pattern of observed anode erosion as explained in section 5.0 indicated that certain geometric changes to the original design would be beneficial with regard to longevity of the propellant retaining shoulder, particularly in the vicinity of the downstream propellant section. For want of some more fundamental solution to the retaining shoulder erosion problem, the "brute force" approach of simply supplying more anode material in the vicinity of the observed severe erosion region is the basic premise for these geometric modifications. A program to investigate this problem in detail will be initiated in the immediate future and a permanent solution will be generated during that program.

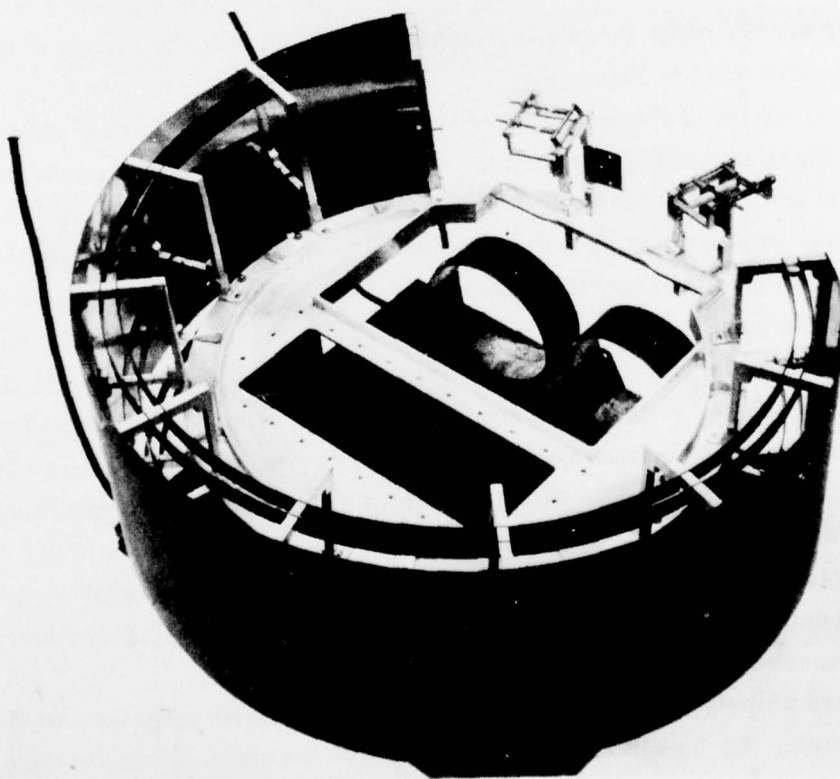
Figure 9. Refurbished Propellant Support Structure

In addition to the two fundamental problem areas noted in the preceding paragraphs, some minor functional problems arose primarily because of the lack of prior experience with a helically coiled propellant system such as this one. In particular the rigidity of the propellant support structure and the importance of the minor deviations from planar geometry were underestimated when the system was first designed. In addition, the frictional forces between propellant rods were also underestimated primarily for the same reason. The consequent large spring forces necessary to feed the propellant rods led to structural deflections which had a tendency to load up the support structure and occasionally bind or misalign the propellant rods. The experience gained from working with the system allowed for formulation of design modifications which in effect eliminated the need for such large springloads and which yielded a more structurally rigid assembly. These modifications are discussed in the next section of this report.

In order to minimize the spring force required to feed the individual propellant sections, the idea of separating the sections using a thin aluminum rail around the periphery of the helix was expanded upon. It was decided to separate the middle from the outer sections of propellant as well as the inner from the middle sections. It was also seen (as a result of the experience generated from working with the system) that the sections should be separated on both the top and the bottom because of the tendency for them to tilt under spring loading and possibly bind together if separated on only one side. Thus, "splitter rails" which separate the three propellant sections from one another on both the top and bottom were incorporated into the refurbished system. The splitter rails were specially coated with TUF-4 Teflon coating process to minimize friction between the rails and the propellant sections. In addition, a continuous aluminum skin was fabricated which ties together all of the propellant support brackets around the outside circumference. A photograph of the complete refurbished propellant support structure is presented in Figure 9.

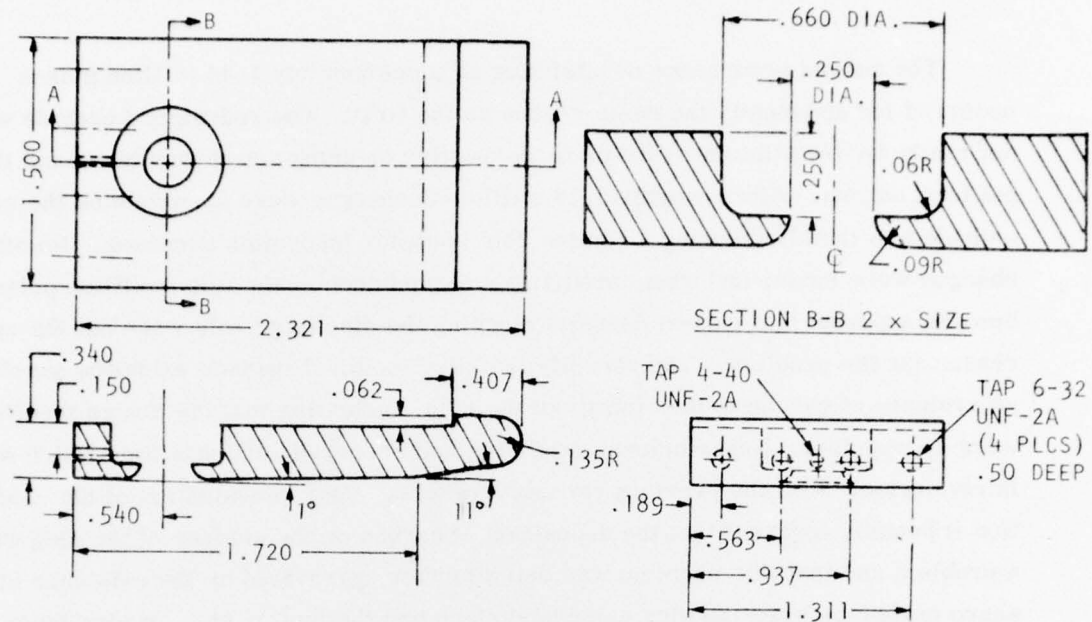
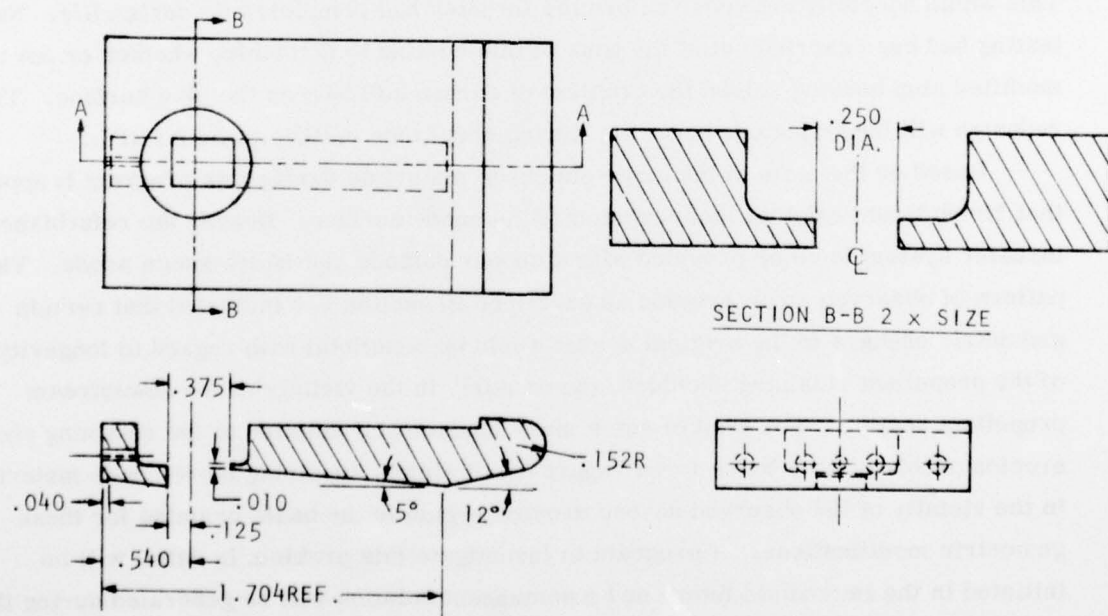
Figure 10. Modifications to Cathode Design in the Vicinity of the Ignition Hole

The thruster misfiring problem was at first thought to be a result of carbon deposition in the hole through which the plug microplasma must pass. Upon changing the cathode geometry in the vicinity of this hole (see section 6.0 for details) and running sufficiently long to evaluate this change it became apparent that the problems encountered were only partly a result of carbon build-up around the downstream periphery of the hole. It was determined that the deposition of carbon on the surface of the ignitor plug itself, causing a short (about 10 ohms) to develop between plug anode and cathode, was accountable for not allowing the plug to break down upon application of the firing pulse. Further analysis of the problem led to a modification in the design of the ceramic plug housing. This modified housing was not installed on the thruster during the endurance test because the need for the modification did not become apparent until very nearly the end of the test. The modified housing will be installed prior to delivery of the thruster to the AFRPL for their in-house testing and evaluation program. Cathode and ignitor plug housing modifications are covered in section 6.0. Presently it is not yet known whether or not this abnormal growth in the carbon deposit could in part be due to the carbonaceous layer of cement that was used between the bonded inner propellant rod (see section 2.4). Future testing with a solid inner propellant rod will hopefully clarify the question.

The first step taken in attempting to resolve the misfiring problem was a redesign of the cathode surface in the vicinity of the ignition hole. The original design called for a 0.25 inch (6.35 mm) dia. chamfered hole in the flat cathode surface as shown in Figure 10a. Carbon deposition on the downstream lip of this hole and subsequent buildup of deposits there caused the hole to become almost entirely closed off by the time the first misfiring was observed. It was reasoned at that time that the downstream lip of the hole represented a stagnation region to the accelerating plasma and that something should therefore be done to minimize the frontal area of this stagnation region and also try to deflect the flow of plasma away from the hole itself. Hence, the configuration shown in Figure 10b was arrived at. Note that the .25 inch diameter circular hole was changed to a rectangular hole 0.25 inches long by 0.375 inches (9.53 mm) wide. The surface of the cathode upstream of this hole is slanted downward at a 5° angle to deflect the plasma flow away from the hole. The cross section of the hole on the downstream side is decreased in area by beginning a constant slope of 5° to the full thickness of the electrode from an initial thickness of .01 inches (.254 mm). The modified cathode was not installed on the thruster immediately following the first misfiring occurrence because the manufacturing time would have caused the system to be down for a longer period of time than was desired. Hence, the original configuration was replaced on test after deposits were cleaned out of the hole and off the surface of the plug.
